Electronic Systems Failures and Anomalies Attributed to Electromagnetic Interference

R.D. Leach and M.B. Alexander, Editor

National Aeronautics and Space Administration
Marshall Space Flight Center • MSFC, Alabama 35812

July 1995

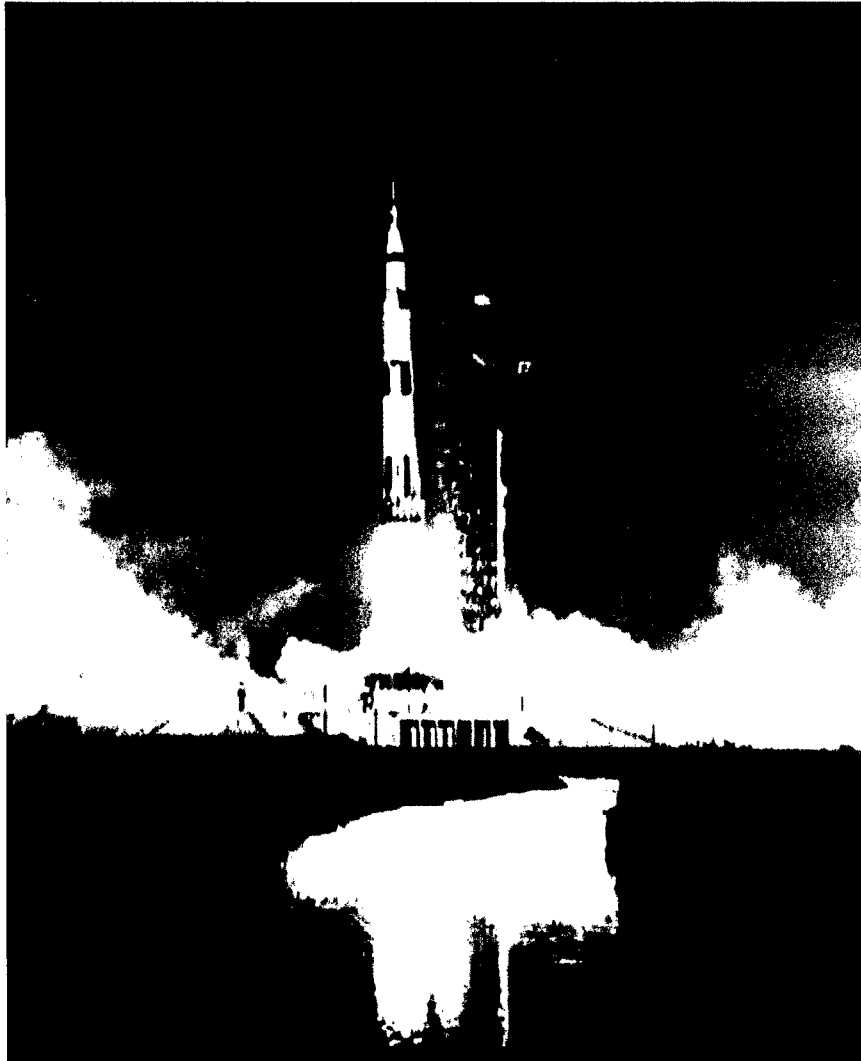
Figure 1. Saturn V launch.

During on-pad checkout at the Kennedy Space Center (KSC) prior to one of the early developmental test flights of the Saturn launch vehicle, the range safety receivers detected an extraneous signal. Because these receivers processed commands for engine cutoff, arm, and destruct, a thorough investigation was conducted to determine the cause of this unintended signal transmission. The problem appeared to be the production of spurious signals originating from the sum and difference combinations possible when signals frequencies are mixed. Although technically these spurious signals are not beat frequencies (associated with sound energy), this particular case is known within NASA as the beat frequency case and is maintained in this report by that title. The spurious signals were caused by the multitude of transmitters located on board to collect test data. Analysis determined that spurious signal frequencies very near the frequency of the range safety receivers were produced by a combination of frequencies from several telemetry transmitters in combination with one of the vehicle’s tracking transponders. Further investigation determined that mixing sources for the signals were the hinged cable tray covers and chain handrails on the gantry. This insight and analysis proved to be useful later. With a Saturn vehicle on pad, the range safety receivers detected a spurious command signal for engine cutoff from a Titan launch vehicle checkout on the next pad. The Titan was using the same modulation frequencies on a different carrier frequency for its range safety receivers. A signal sent to the Titan vehicle was also received by the tracking transponder on the Saturn vehicle. The retransmitted signal of the transponder was mixed with certain telemetry signals resulting in the false engine cutoff command. After this incident, the decision was made to fly with the culprit transponder inactive (eventually it was removed from the vehicle). Later, both

telemetry and range safety transmissions were moved to a higher frequency range where the production of spurious signals did not interfere with the range safety system.⁵

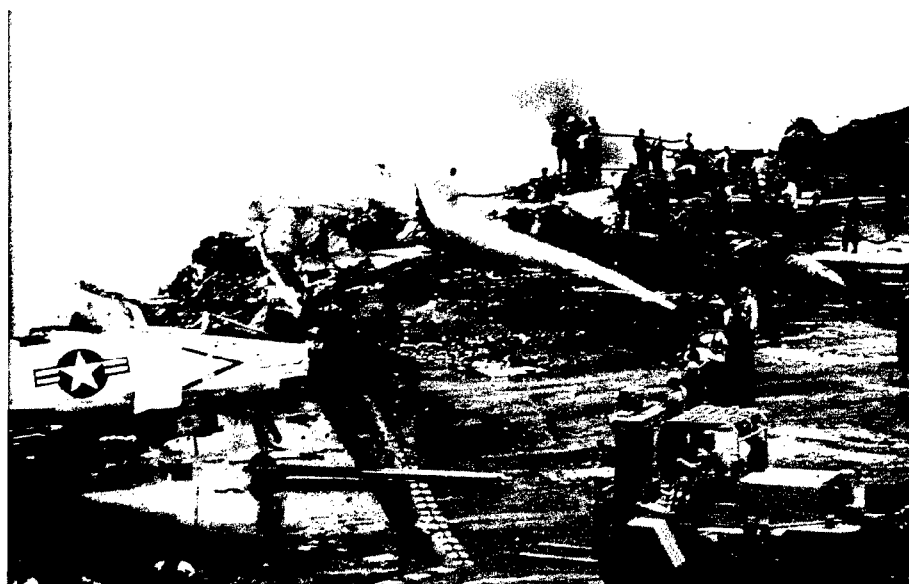
Figure 3. Aftermath of U.S.S. *Forrestal* EMI incident.

In 1967 off the coast of Vietnam, a Navy jet landing on the aircraft carrier U.S.S. *Forrestal* experienced the uncommanded release of munitions that struck a fully armed and fueled fighter on deck (fig. 3). The results were explosions, the deaths of 134 sailors, and severe damage to the carrier and aircraft. This accident was caused by the landing aircraft being illuminated by carrier-based radar, and the resulting EMI sent an unwanted signal to the weapons system. Investigations showed that degraded shield termination on the aircraft allowed the radar frequency to interfere with routine operations. As a result of this case, system level EMC requirements were revised to include special considerations for electroexplosive devices.¹²

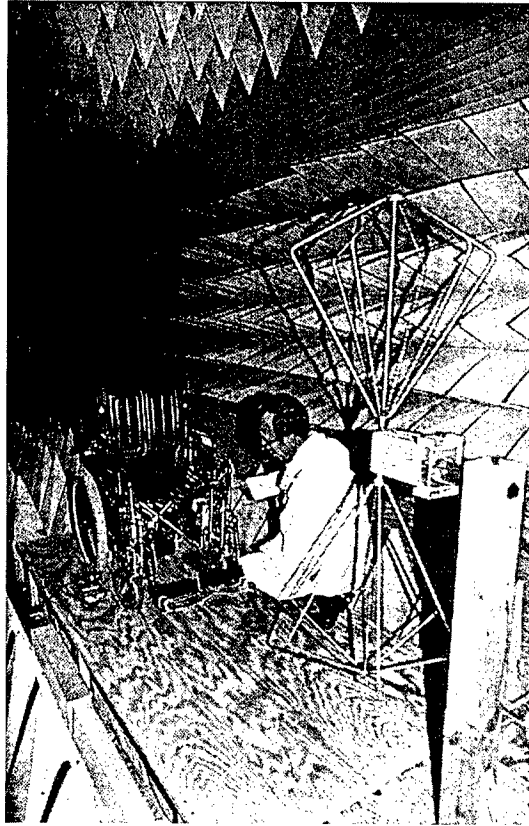
Figure 5. Testing a wheelchair for EMI.

Wheelchairs came under the scrutiny of the FDA (fig. 5) because of reported erratic, unintentional powered-wheelchair movements. These movements included sudden starts that caused wheelchairs to drive off curbs or piers when police, fire, or CB transmitters were activated near the chairs. Although no fatal injuries have been reported, FDA has ordered manufacturers of motorized wheelchairs to shield them from EMI and to educate users on the potential EMI hazards.²¹
