MIL-STD-1505(USAF)
6 July 1971

REFURBISHMENT PROCEDURES
ROCKET MOTOR, AIR-2A

REFURBISHMENT PROCEDURES, ROCKET MOTOR, AIR-2A

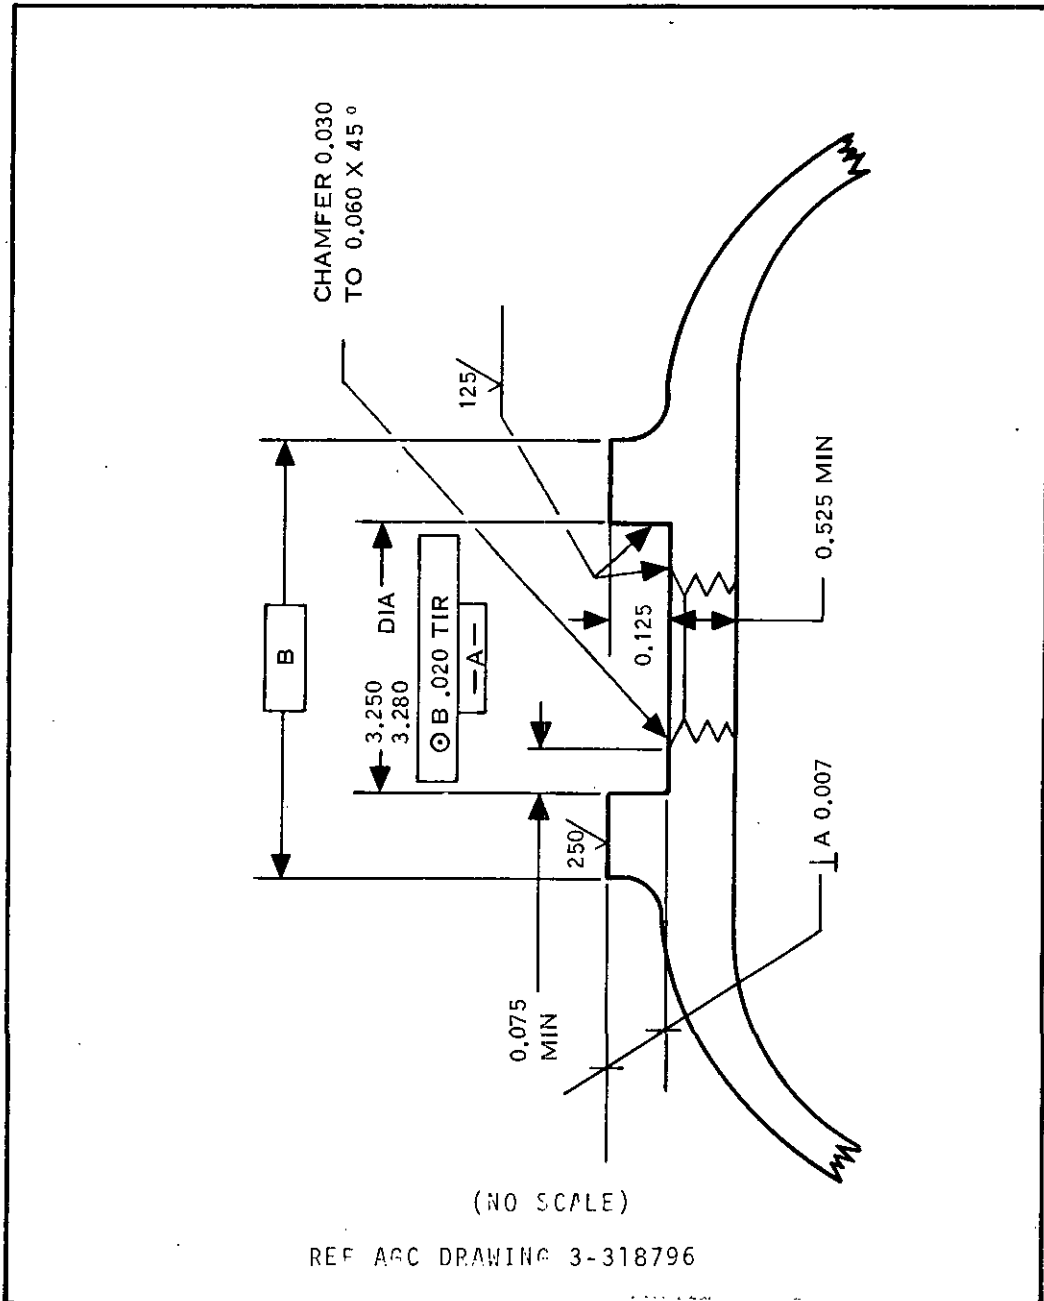
FIGURE 1

REWORKING OF IGNITER BOSS

- a. Surface defects not in excess of those specified in 4.12.16.5 may be reworked by cadmium plating (Dalic Process or per QQ-P-416), to a minimum thickness of 0.002 inch. The plating shall be of sufficient thickness to give a maximum depth of 0.005 inch after plating.
- b. Surfaces with pits in excess of 4.12.16.5 may be reworked according to Figure 1.
