# Composite Structure Repair

AGARD Report No.716  
COMPOSITE STRUCTURE REPAIR

Larry G.Kelly  
AFWAL/FIBC  
Wright Patterson AFB  
OH 45433  
USA

Paper presented at the 57th Meeting of the Structures and Materials Panel in  
Vimeiro, Portugal on 9-14 October 1983.

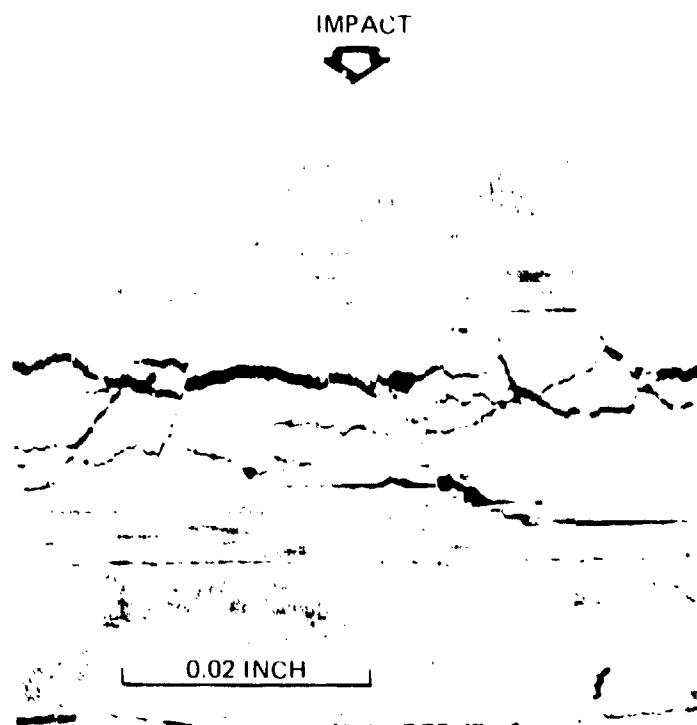
8 PLYS GR/EP (# 45/0/90)<sub>s</sub>

BLUNT IMPACTOR AT CENTER OF 5 INCH SQUARE AREA  
 TOTAL ABSORBED ENERGY = 1.24 FT-LB  
 (INCIPIENT DAMAGE INDICATED AT 0.82 FT-LB)  
 DAMAGE NOT VISIBLE ON IMPACTED SURFACE  
 SLIGHT MATRIX CRACK ON BACK FACE

Figure 1. Photomicrograph of Impact Damage Laminate

General impact damage and specifically ballistic penetration of a composite laminate results in holes in the laminate which are irregular in contour and generally jagged in appearance. Delaminations, void areas and ruptured filament bonds may occur anywhere throughout the thickness, but generally to a larger extent on the opposite side of the impacted face or exit side of the projectile path. In some cases, impacts which cause very little damage on the surface can cause internal cracking and delamination. These interlaminar defects can be readily detected with ultrasonic equipment and it is a good rule that any damage which is visible on the surface should be further evaluated for internal damage. Examples of extensive internal damage where surface damage is minor are shown in Figures 1 and 2.

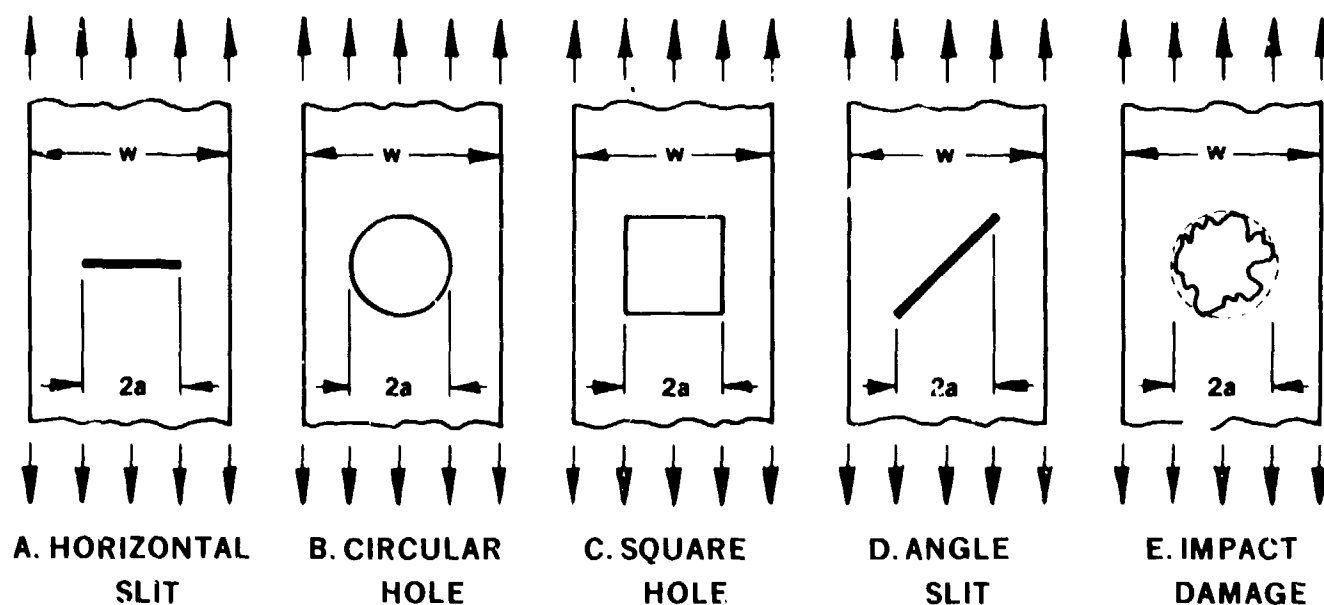
Figure 4. Examples of Through-Thickness Defects Having Same Tension Failure Loads

Some test results, Reference 2, indicate that for a given panel width and laminate orientation various through-the-thickness crack geometries having the same crack width, as shown in Figure 4, failed at essentially the same tension load. Thus assuming damage to consist of a through-the-thickness defect equal in width to the maximum damage dimension (as determined by ultrasonics) perpendicular to the primary load path, linear elastic fracture

mechanics can be utilized to obtain an estimate of the strength lost. This approach of modeling damage effective strain concentrations as that of an equivalent open round hole can sometimes be unconservative but a useful technique to obtain a "ball park" estimate of how much strength has been lost.

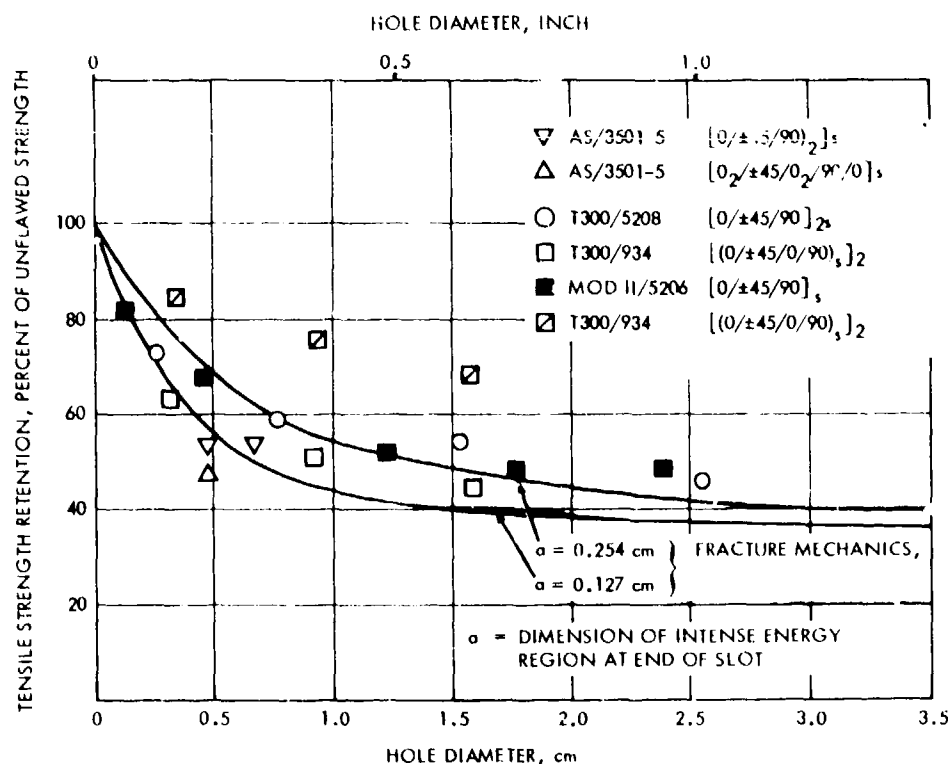
Figure 5. Tensile Strength Retention of Laminates with a Hole

Figure 5, from Reference 3, shows that there is substantial strength loss in carbon composites with relatively small holes.

Current design practice in the U.S. is to limit ultimate strain allowables in carbon composite structures to approximately 3500-4500 $\mu$  in/in. This allows for stress concentrations due to bolt holes or notches and provides for some accommodation of strain concentrations due to defects or damage. The figure 5 data does, however, point out the need for good quality repairs with substantial load carrying capability especially for structures designed with higher strain allowables.

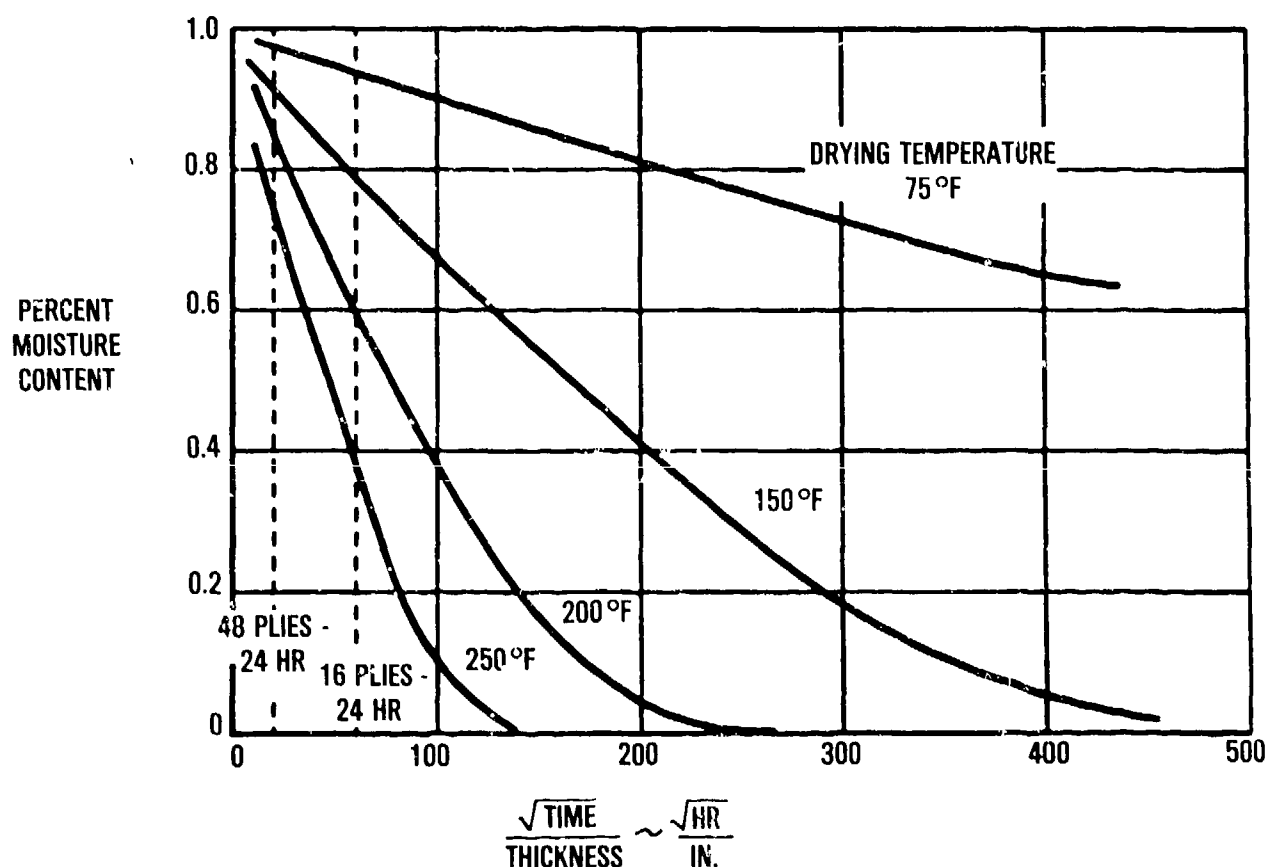
Figure 7. Drying Time for Carbon Epoxy Laminates

Prebond drying (a minimum of 48 hours at 170°F-200°F), slow heat up rates, reduced cure temperatures and selection of adhesives less sensitive to moisture can minimize or eliminate the above problems. The 250°F curing adhesives, as a group, are more sensitive to prebond moisture at higher temperatures (above 150°F) than 350°F curing adhesives. Drying the parent laminate to an average moisture content of less than .5 percent is recommended. This can be very time consuming taking over 24 hours for a 16 ply laminate, as shown in figure 7.

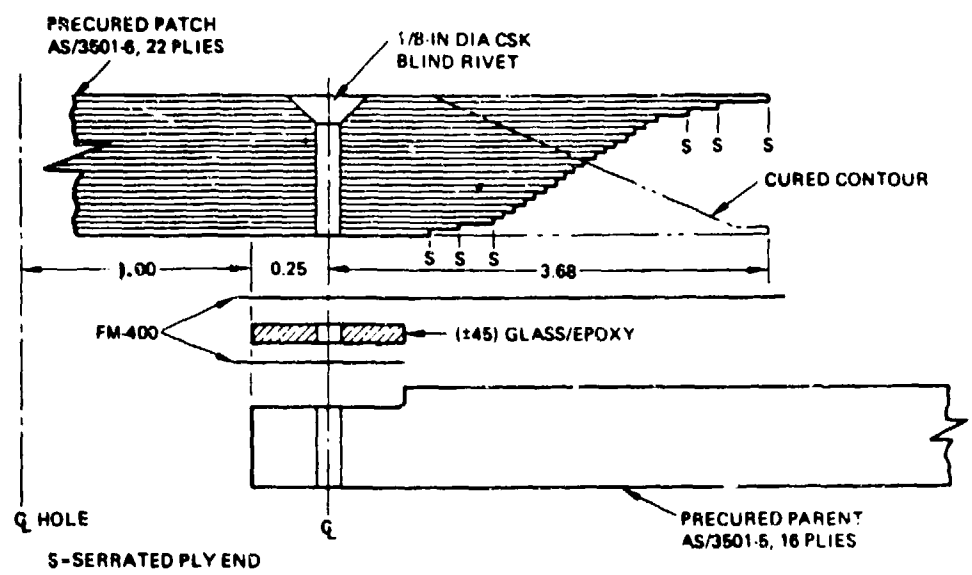
Figure 9. External Patch Repair

Applying this concept to 2" diameter holes in four-point-load sandwich beams obtained the results shown in Table 1. Figure 9 shows the details of the 22 ply patch design. Comparing the resulting failure loads with the parent allowables quite satisfactory results were obtained for low to intermediate load levels (6-7,000 lb/inch).

Having established the capability of composite scarfed joints to satisfactorily transfer the required loads, the application of this repair concept (Figure 11) and that of the precured external patch (Figure 9) was applied to the repair of 4 inch diameter holes in 12 inch by 48 inch panels (Figure 12).

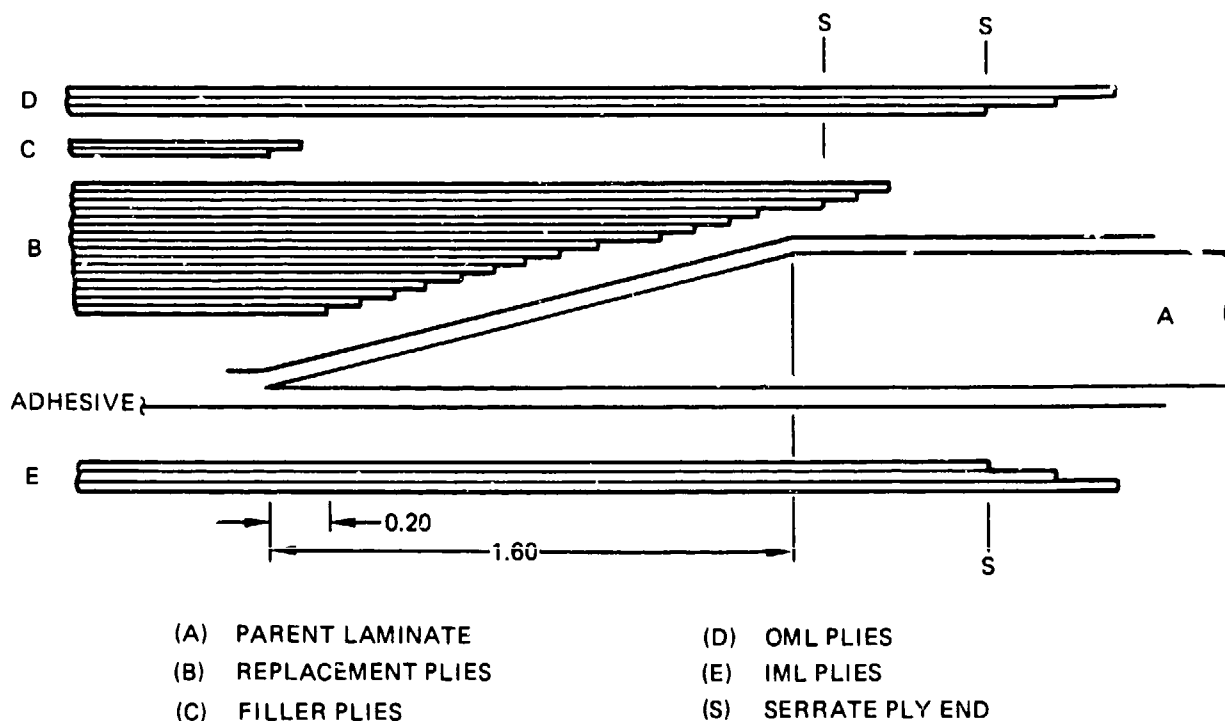
Figure 10. Basic Cured 16-Ply Scarf Joint

Precured bonded composite doublers, discussed previously, metal sheets and plates and metal foils of 8, 12 and 16 mil thickness have all been utilized satisfactorily as patch materials for low load levels and relatively flat surfaces. For curved or irregular surfaces and intermediate to high load levels the most versatile repair concept is the cured in place flush scarf repair. Accomplishing the scarf may appear difficult at first but was found to be relatively easy with simple portable tools. As a general rule when making a large area repair a flush scarfed repair is preferred since a significantly higher percent of the strength of the parent laminate can be restored. This is especially true for compressive loading where eccentricity of the patch can increase bending forces. Practical size limitations will probably restrict this repair approach to laminate thicknesses less than 1/2 inch because of the amount of material that has to be removed to achieve the required taper for proper scarf angle ( $L = 18$  to 40 times the thickness). Figure 10 illustrates a typical scarf joint using a 16 ply laminate to be repaired.

This basic scarf joint employs an 18:1 taper ratio since a .10 inch step is 18 times the nominal ply thickness of (.0055 inch). The scarfing is accomplished quite readily with the use of a portable router to cut .10 inch concentric steps, each successively larger, followed by a portable power driven sander to provide a finished scarf. A good scarf patch design practice is to extend the outermost plies over the ends of all the other plies and to serrate these plies to minimize ply end peeling. This can easily be done to the edge normal to the fiber direction with a pair of standard 1/8 inch V-notch pinking shears. It is also good practice to avoid placing unidirectional material as the outer most ply. An outside cover of woven material or for balanced

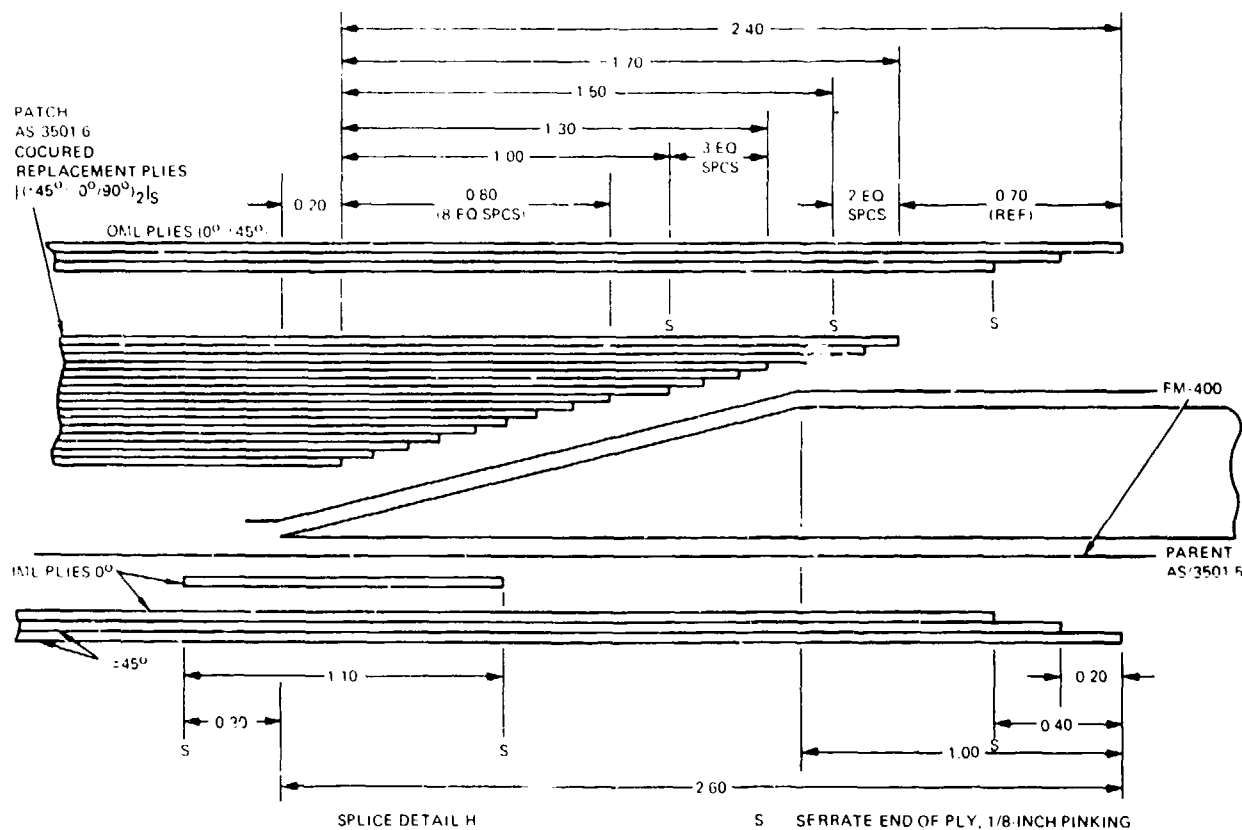
Figure 11. Flush Scarf Repair

Repairs up to 100 inch sq. in 16 and 24 ply laminates have restored 80-100 percent of the parent laminate allowable utilizing the techniques described above. This has been verified through a series of repair joint coupons, sandwich beams, flat panels and box beam tests. First 1" wide tension coupons and compression sandwich beam specimens of the scarf design shown in Figure 11 were tested with the results shown in Table 2.

The test results shown in Table 2 are for specimens consisting of a parent laminate of AS/3501-5  $[(0/+45/90)_2]_S$  that was scarfed over a length of 1.6 inches and a patch laminate of AS/3501-6 plies, per Figure 11, that was cocured and bonded to the scarf. Comparing the failure loads for these joints to that of the parent laminate allowable, quite satisfactory joint load transfer efficiencies were achieved.

(a) Splice details shown in Figure 11.

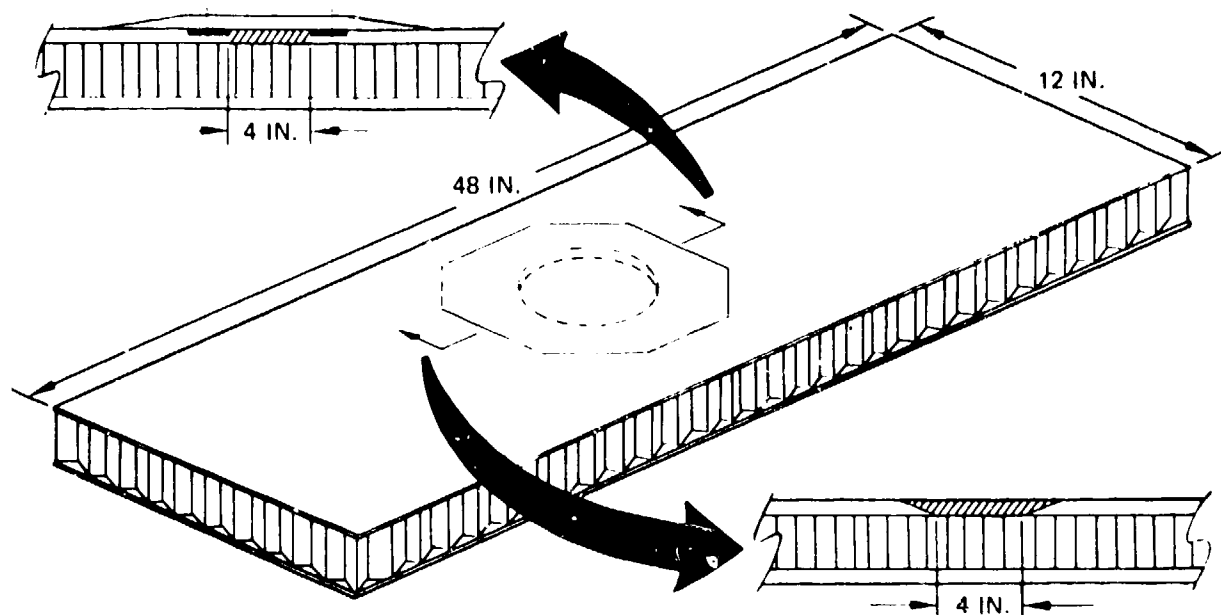
Figure 12. Intermediate Size Panel Repairs

The results of these panel tests are shown in Tables 3 and 4. All 14 panels were tested as four point beams with either a constant applied tension or compression moment in the repair section. The better load transfer capability of the flush scarf repair is evident even at these low load levels. The precured external patch performance in compression was unsatisfactory in terms of load restored, only 66-69% of the parent allowable.

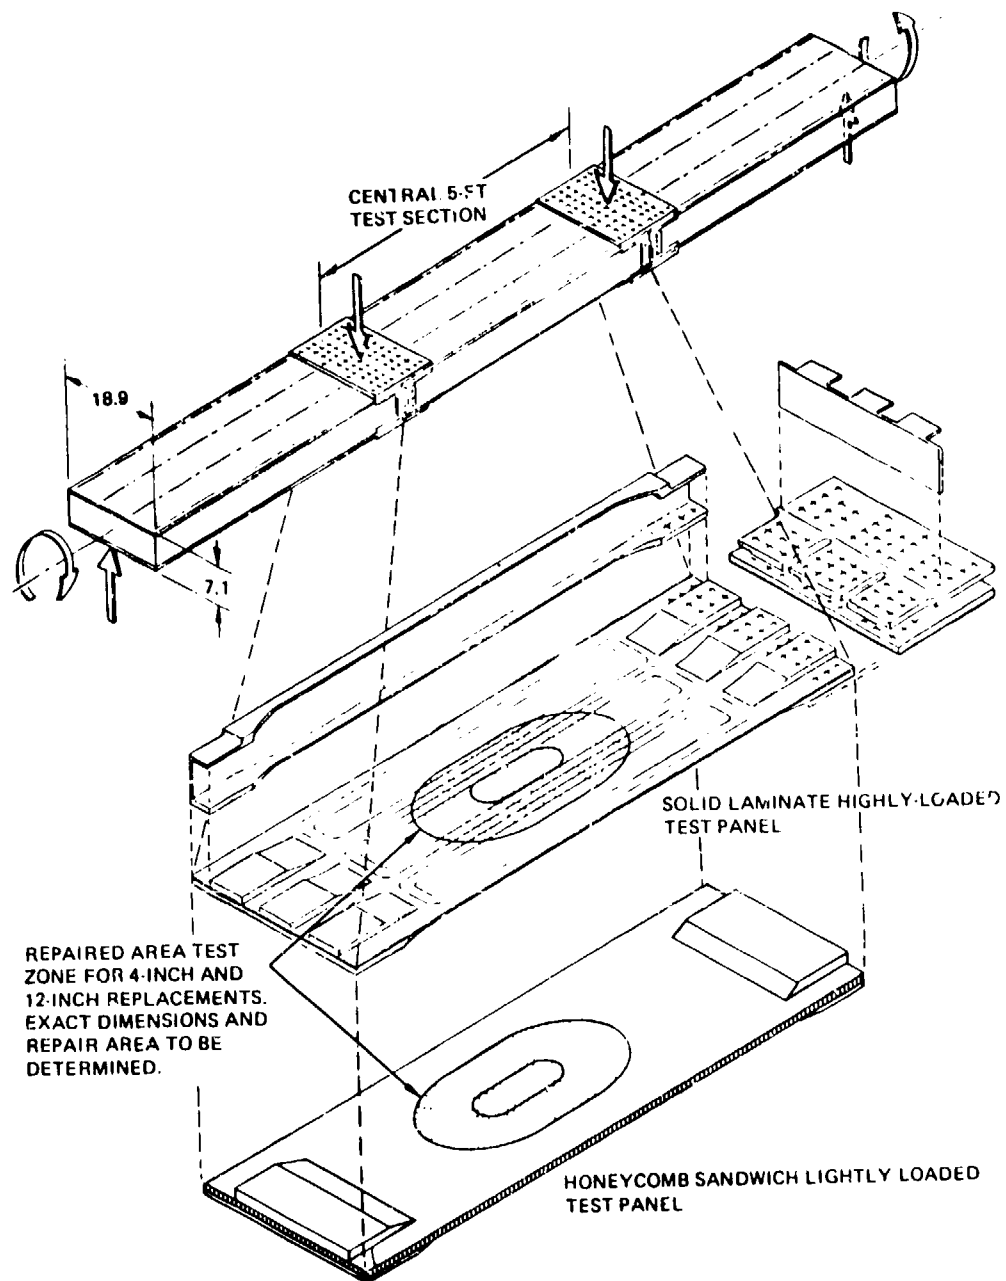
Figure 13. Large Scale Demonstration Panel  
Box Beam Test Fixture

The final demonstration of the repair concept developed was accomplished through the use of a 17 foot long, 19 inch wide, 7 inch deep box beam to which four point bending and torsion loads can be applied to the tension cover of a five foot test section, Figure 13. The five test panels and repair techniques utilized are outlined below:

- Panel 1. Honeycomb Sandwich Panel (8 ply laminates on .5 inch thick aluminum core)  
 Damage: 6" x 12" oval hole completely through after clean up  
 Repair: 13 ply bonded cocured scarf patch to both facesheets (36:1 taper) + core plug
- Panel 2. Honeycomb Sandwich Panel (8 ply laminates on .5 inch thick aluminum core)  
 Damage: 6" x 12" oval hole after clean up on front face and a 1" x 6" hole on the back face  
 Repair: 5 ply precured blind side patch + 13 ply bonded cocured scarf patch for inner and outer faces + core plug

- Panel 3. 50 Ply Laminate  
 Damage: 8" x 12" oval 21 plies deep after clean up  
 Repair: 24 ply bonded cocured scarf patch (36:1 taper) at ends  
 (18:1 taper) at sides
- Panel 4. 50 Ply Laminate  
 Damage: 4" diameter hole completely through  
 Repair: 61 ply cocured double scarf patch (36:1 taper)
- Panel 5. 64 Ply Boron/Carbon Epoxy Hybrid Laminate  
 Damage: 9" diameter 24 ply cut out after clean up  
 Repair: 77 ply bonded cocured scarf patch (55:1 taper) at ends  
 (18:1 taper) at sides

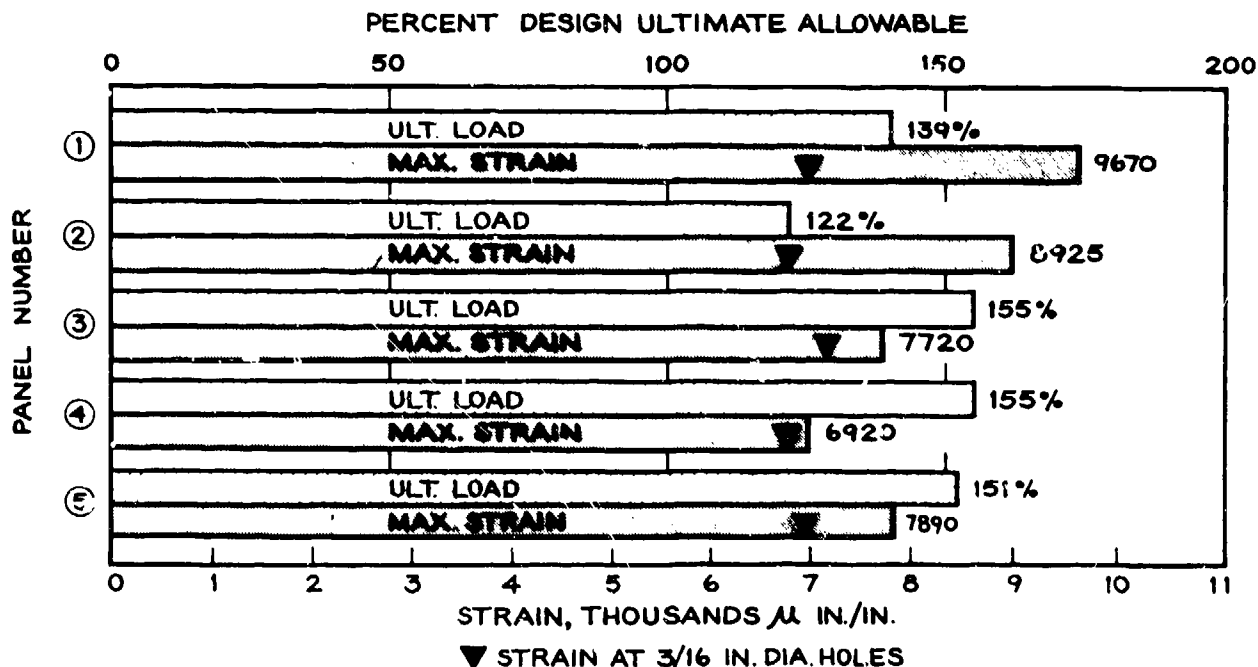
Figure 14. Demonstration Panel Results

Test results for these five panels are shown in Figure 14 and summarized below. More details on these test results can be found in Reference 6.

- Panel 1. Failure was remote from the patch area at 139% of the parent ultimate tension allowable at a failure load of 2390 lbs/inch
- Panel 2. Failure was through the repaired area at 122% of the parent ultimate tension allowable at a failure load of 2095 lbs/inch
- Panel 3. Failure was remote from the patch area at 155% of the parent ultimate tension allowable at a failure load of 14,200 lbs/inch
- Panel 4. Failure was through the repaired area at 155% of the parent ultimate tension allowable at a failure load of 14,200 lbs/inch
- Panel 5. Failure was remote from the repaired area at 151% of the parent ultimate tension allowable at a failure load of 19,300 lbs/inch
