Inspection of Wood Beams & Trusses

NAVFAC MO-111.1

September 1985

Facility Condition Evaluation Standards are given for timber trusses and laminated wood arches. Various types of deficiencies are discussed and a rating system is derived and applied to typical deficiencies found in timber structures.

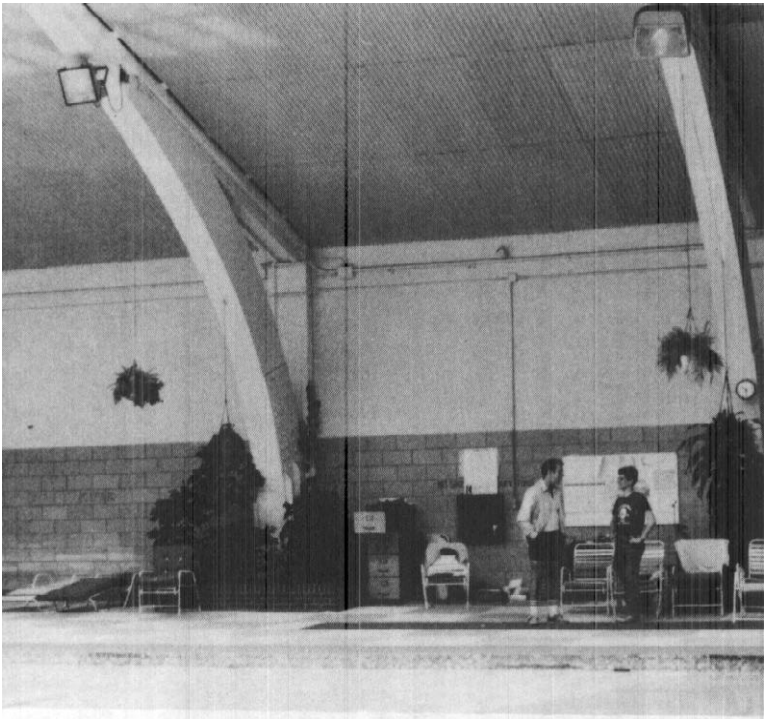
Figure 4-2. Glulam arches with rating 100. No sign of deflection or deterioration.

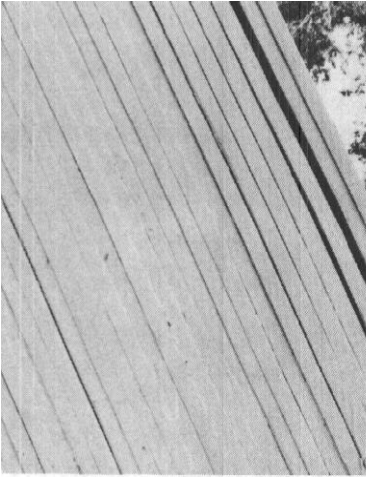
Figure 4-5. Glulam arches with rating 40. (A) Severe delamination in a localized area in the outer laminations.
